Sega/Stern White Star Repair

From PinWiki

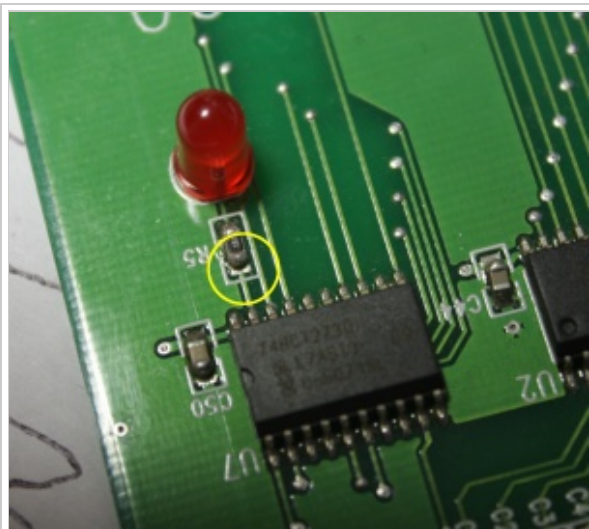
A fractured solder joint (circled) on this board prevented the "power on" LED from ever lighting.

The surface mount version of this board sometimes has dubious solder connections at some of the surface mount resistors and capacitors. The picture at left shows a fractured solder joint on the resistor in series with the "power on" LED. The LED would never light. Another fractured solder joint on the same board prevented the reset pulse from the MPU board from ever reaching the on board 68B09E.

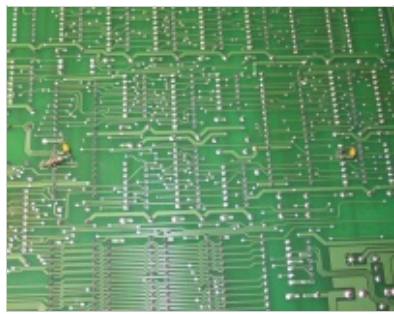
Pictured at left, are two factory updates to the original Sega/Stern White Star MPU (BMST2000 version). These are normal, and not "hacks".

Factory updates to the Sega/Stern White Star MPU.

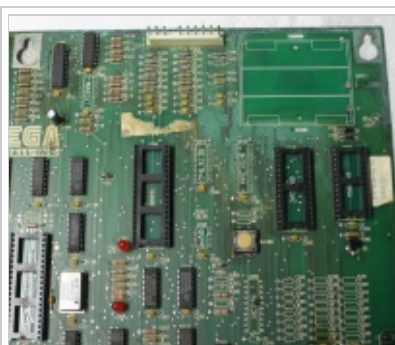
The aftermath of batteries which leaked. This board is beyond repair, and good only for salvage parts.

Relocating the 3xAA batteries off the MPU board or installing other alternatives for memory retention is always a good idea. Leaky alkaline batteries are the #1 killer of pinball boards.

Whatever you do, **GET THE BATTERIES OFF THE BOARD!** It's not a matter of if they will leak, it's a matter of when. White Star boards are pricey to replace, and repair is difficult/expensive/even impossible due to the very fine traces used on the board.

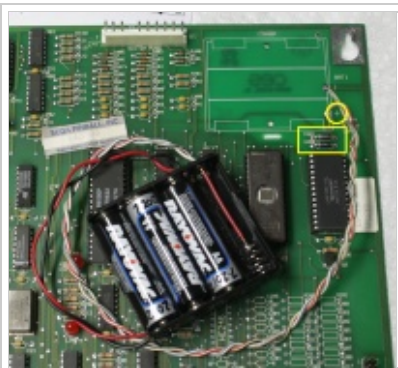
A White Star MPU Board with Remote Battery Pack Connected. The Positive (+) terminal is circled. D200 and D201 are highlighted inside the rectangle. Note that the battery installation date is recorded with a Sharpie. Also note the **long** wires, allowing the holder to hang well below the backbox boards, another precaution for leaky batteries.

Adding a connector between the battery pack and the MPU board is a good idea. In doing this, the battery pack can easily be removed from the MPU board. Plus, if the batteries are forgotten, and do leak, the MPU board may not have to be removed to add another battery pack. A 3 x AA battery holder is the typical recommended replacement. If only a 4 x AA battery holder is available, a jumper can be soldered in the first battery position. Likewise, a diode can be placed in this position. Using a diode instead of a jumper will prevent the batteries from being charged and 'cooked' by the game if blocking diode D201 on the MPU board fails. Keep in mind that a second (redundant) diode added to the circuit will reduce the backup voltage to the RAM memory by .5 to .7 volts. Install a 1n4001 or 1N4004 diode in the position closest to the last + terminal (where the Red Wire exits). The banded side of the diode must be pointing in the direction of current flow, which is towards the (+) terminal marking on the MPU board, and away from the battery pack.

After adding a remote battery pack, and while the board is still out of the game, it is a good practice to measure the battery pack's voltage at the **VBATT** test point on MPU board. All battery packs are pretty cheaply made, and failures "out of the box" are somewhat common. Checking to make certain the battery pack is functioning before reinstalling the MPU board in the game will save some headaches.

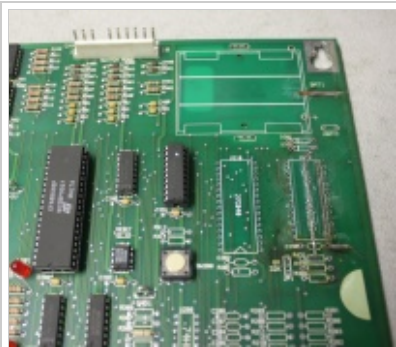
This MPU sustained alkaline damage. Sockets for the 68B09E processor and the 6264 RAM have been removed.

Argh! The MPU pictured at left has sustained alkaline damage. In this case, the damage was repairable. Most of the time, alkaline damage to White Star MPUs is more substantial and beyond economical repair.

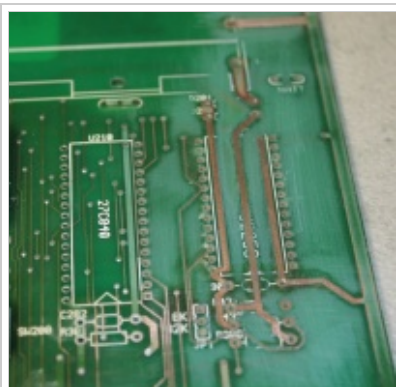
More components removed, the alkaline damaged traces sanded, and the damaged area treated with 50/50 vinegar and water.

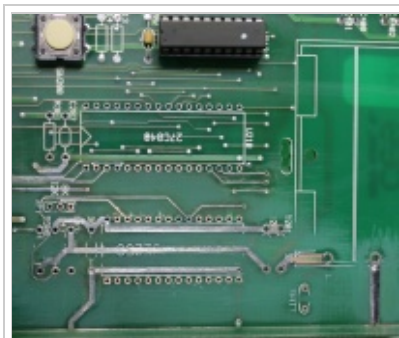
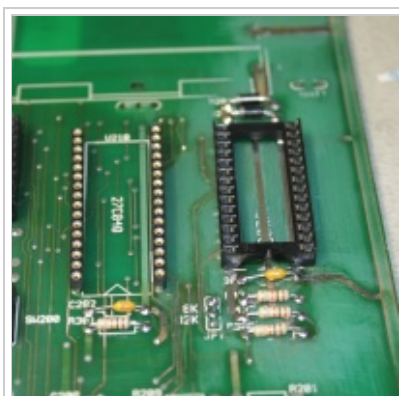
Bare copper traces tinned.

The completed board shown on the left took a few hours to cleanup, repair, verify, and game test.

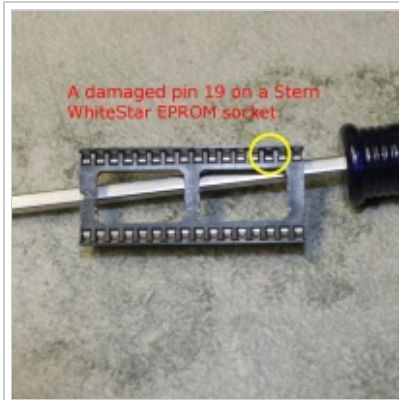
A damaged EPROM socket from a Sega/Stern White Star MPU

A damaged socket for either the game ROM or the 6264 RAM can cause a game to continually reset. This happens because the CPU can not fetch and execute instructions from the game ROM, or it is unable to read/write data to/from the RAM correctly. A simple replacement of damaged OEM sockets sometimes corrects a reset issue.

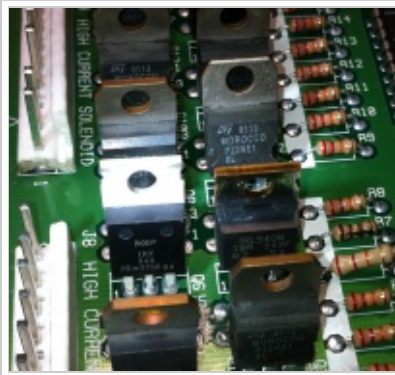
Danger Will Robinson...the IRF540 installed at Q6 shown above, is the wrong part. The original 22NE10L should be replaced with an IRL540, like the one to it's immediate right.

The White Star driver board first used STP20N10L FETs to drive high current circuits, like solenoids. When they were discontinued later boards used the STP22NE10L. Since the 22NE10L is obsolete and even the current replacement, the STP40NF10L is hard to find, the IRL540 or IRL540N are the recommended replacements. If available get the IRL540N because it has a higher drain current rating of 36A.

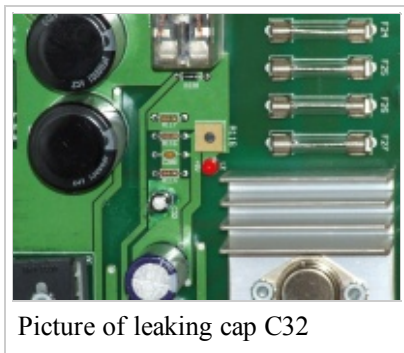
Picture of leaking cap C32

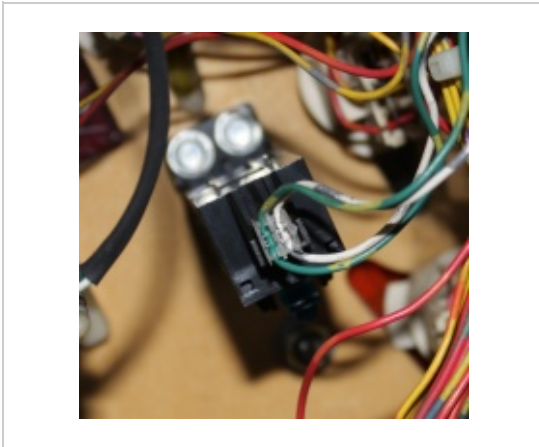
The Achilles Heel of a Sega target...the IDC connector.

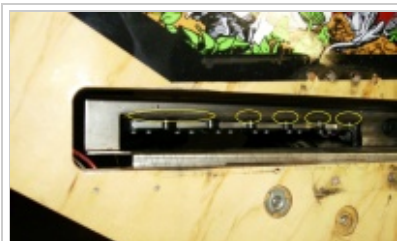
Ball trough assembly with divots. Although it's not a White Star game, Jurassic Park is used for this example.
