Sega/Stern White Star Repair

From PinWiki

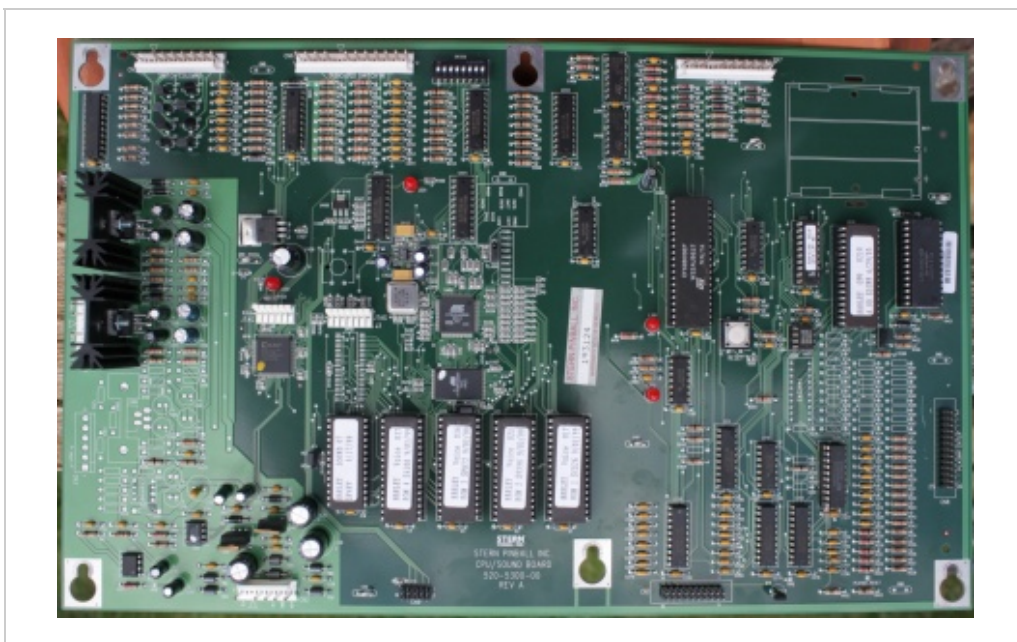
Stern White Star CPU/Sound Board II 520-5300-00 (LOTR and forward). U201, U213, and U413 are socketed on this board as a result of alkaline damage abatement.

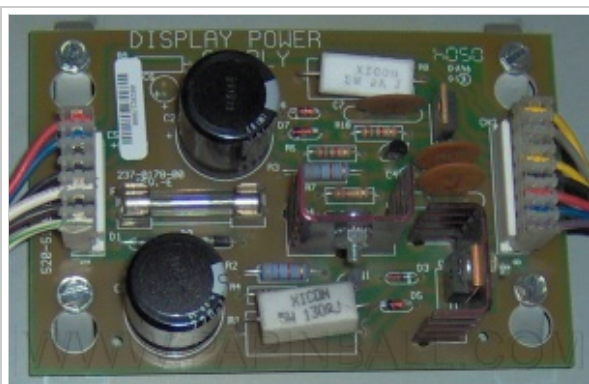
Stern 520-5138-00 Display Power Supply

Common failures:

-110V missing or too low

-98V missing or too low

+68V missing or too low

A blowing fuse is often caused by a defect rectifier diode D1 or D2 (1N4004, can be replaced by 1N4007). When D1 was defect and replaced there's a big chance that Q1 and Q3 are defect as well. When D2 was defect and replaced often Q2, Q4 and Q5 are defect too.

-120V problems are often caused by a defect transistor on Q2 (MPSA42) and/or Q4 (MJE15031) when one of the transistors is defect there's a big chance the other is defect as well. Replace zener diode D4 (3.9V), D6 (100V) and D7 (13V) as well.

-100V problems are often caused by a defect transistor on Q5 (MJE15030) or zener diode D6 (100V), it's best to replace both. The 2k/5W resistor on R8 might also cause the problem, mostly because of bad solder contacts.

+60V problems are often caused by a defect transistor on Q3 (MJE15030) and/or Q1 (MPSA92) when one of the transistors is defect there's a big chance the other is defect as well. Replace zener diode D3 (3.9V) and D5 (68V) as well.

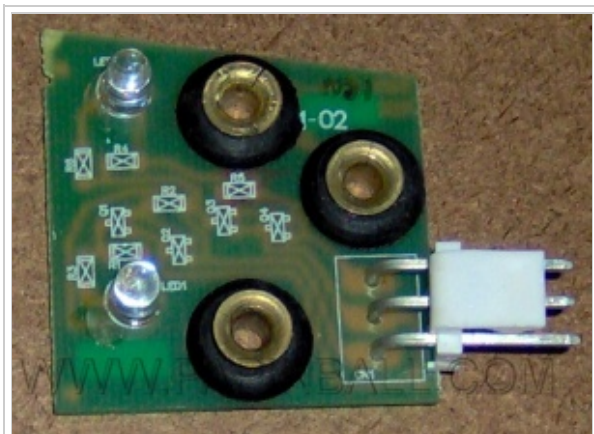
Stern White Star Trough Opto Receiver (Later Games)

Once significant source of trouble with these trough boards is fractured header solder joints.

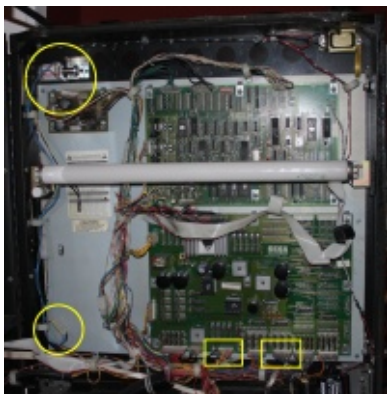
In the picture at left, we show all the components necessary to add a knocker. The new knocker is circled, top left. We've used an in-line connector along the wiring, also circled, lower left. The power and ground connections are noted by the rectangles.

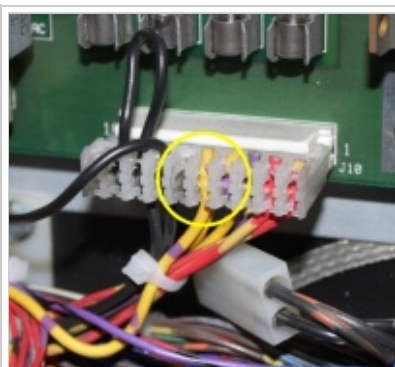
Adding a wire to provide the knocker with 50V power.

Here I've stuffed another wire (yellow with purple tracer) on top of the solenoid power supply at J10, pin 5. This wire will eventually be connected to the banded side of the knocker coil.

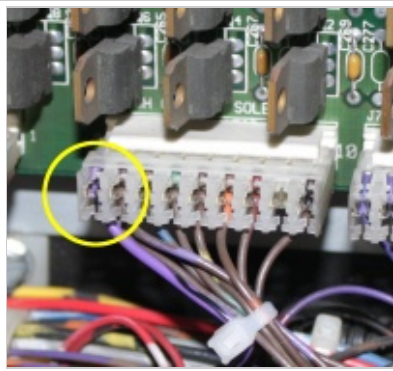
Adding a wire to provide a path to ground for the knocker, typically called the solenoid drive.

Here I've stuffed another wire (purple with black tracer) on top of the solenoid 8 drive connection at J8, pin 9. This wire will eventually be connected to the non-banded side of the knocker coil.

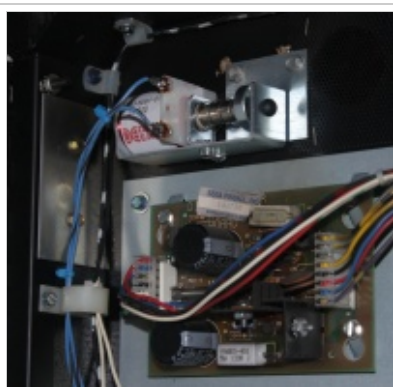
The new knocker, screwed to the cabinet upper left corner...not much room there. Also add the "strike plate" to the cabinet side.

Of course, you need to procure the actual knocker hardware, and connect it as shown in the prior pics. In the picture at left, we've added a Sega knocker assembly and strike plate.

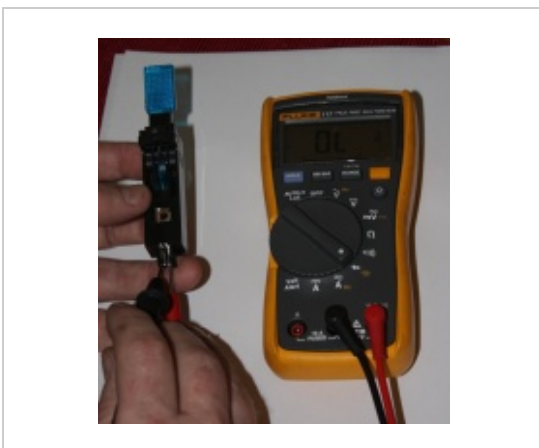
Testing a closed target switch, step 1. In diode test, with the switch closed, your meter should read 0 or null.

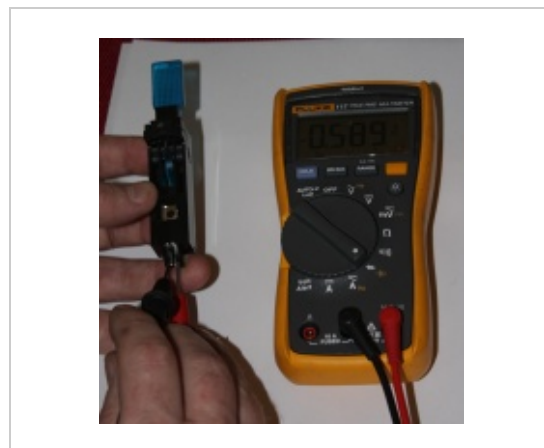
Testing a closed target switch, step 2. In diode test, with the switch closed, your meter should read .5 to .7, the nominal voltage drop across a diode.

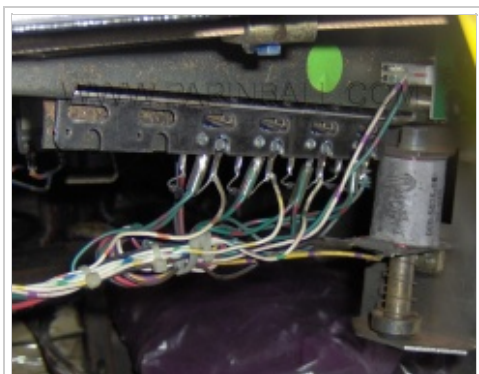
Typical Sega ball trough assy. using 1/8" screws heads

As with any sub microswitch, the switches can become sporadic or fail over time. Another thing that can happen is the switch arm can break at its pivot point. This happens with this style of switch more frequently than other styles, because the metal arm is placed between two plastic ears. With nearly every other style of sub microswitch, the arm has the metal ears which go over plastic nubs on the switch body. The correct replacement switches are 180-5119-00

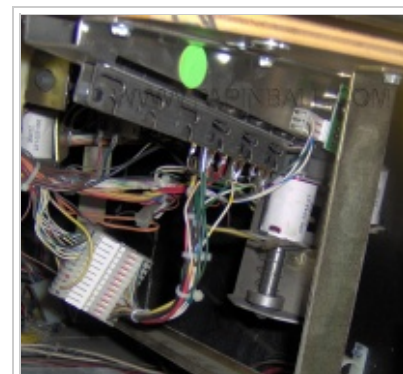
There may be other issues, which appear to act like ball trough switch failures. One of the problems is divots in the ball trough itself. After many iterations of the balls slamming into the trough over and over, divots start to develop. This divots can keep balls from rolling down the trough assembly. In turn, the balls will not be closing the proper switches in the trough. The end result is a game that "loses its mind". If the balls are not where they are expected to be in the trough, the game cannot function as intended.

Typical Stern ball trough assy.using 3/16" screws heads

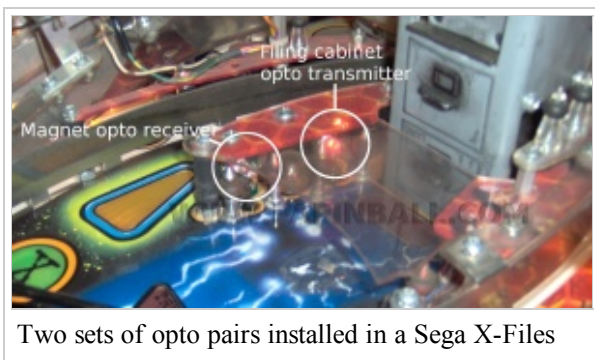
Two sets of opto pairs installed in a Sega X-Files

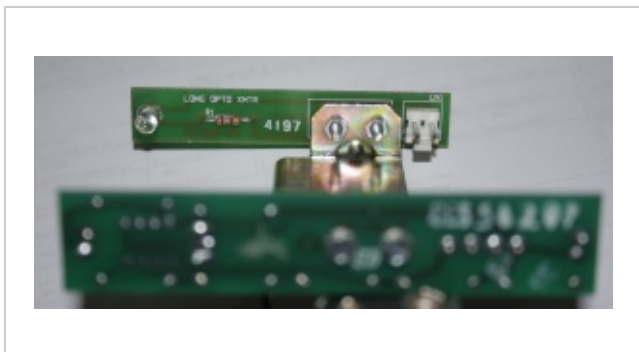
The opto transmitter side.

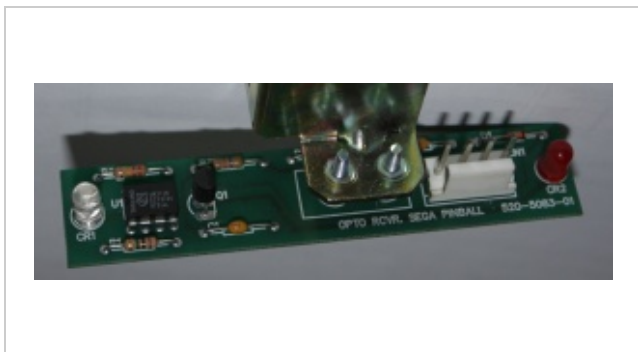
The opto receiver side, with accompanying electronics. The red colored LED is a diagnostic aid to indicate a detected switch closure.

Depending on the exact circumstances, and the era of the White Star game, one or two of these symptoms can occur. The crux of the problem is either one or both of the two trough LED opto transmitters or receivers is failing. Rarely do the components on the trough opto boards other than the red LEDs actually fail though. And in most cases, it is not the LED itself, although, there are some instances when the problem is a failing LED. It is noteworthy that the issue is more common to the opto receiver side more so than the opto transmitter side.

White Star games initially used MT5000UR ultra-bright red LEDs, while later games used TLRH180P ultra-bright red LEDs for both the transmitter and receiver boards. Both styles of LEDs have become expensive and fairly difficult to source. Great Plains Electronics offers the MV8114 (<http://www.greatplainselectronics.com/search.asp?pg=1&stext=MV8114&sprice=&styp=&scat=>) as viable replacement for either original, factory LED. The only caveat is that both the transmitter and receiver opto LEDs must be replaced in pairs to ensure proper function.

When replacing the opto LEDs, make certain the base of the LED is placed squarely on the PCB. An LED which is poorly installed may result in sporadic switch closures.

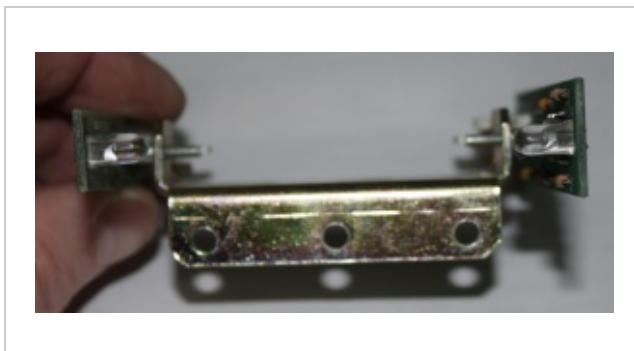
An opto pair. The pair must be in perfect alignment or the opto switch will operate unreliably.

Similar to the discussion above, "Two Balls Served, Continuous Balls Served to the Shooter Lane, or the Trough VUK Fires Repeatedly", other opto pairs in the game may fail over time and become unreliable. Usually this manifests as phantom switch closures. Games like Starship Troopers that use an opto pair for both the left and right orbit shots may score the orbit shot randomly or even continuously. If the "long hop" opto assembly is removed, you may find that the opto pair registers correctly if the optos are aimed with great accuracy at one another. However, the slightest misalignment (like flexing the PCB) will cause the opto pair to register a "hit".

The correction for this is again to replace the original MT5000UR or TLRH180P ultra-bright red LEDs, with MV8114 (<http://www.greatplainselectronics.com/search.asp?pg=1&stext=MV8114&sprice=&stype=&scat=>) LEDs from Great Plains Electronics.

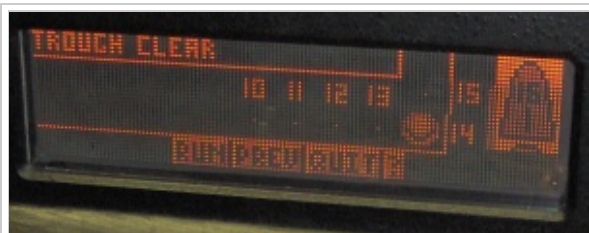
A Stern Monopoly in "Clear Ball Trough" Mode Identifying One Ball in the Trough

If the any of the previously mentioned symptoms are evident, the best approach is to first put the game into "Clear Ball Trough" mode via the Portal buttons on the coin door. Consult the manual documentation for details how to enter this test. Once all of the balls are removed from the trough, no balls should display on the DMD display. If either of the two images shown to the left are displayed on the DMD, and the ball trough no longer has any balls present, there is a problem with either the transmitting or receiving opto boards.

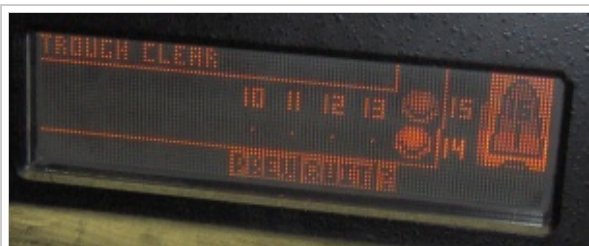
A Stern Monopoly in "Clear Ball Trough" Mode Identifying One Ball in the Trough and One Ball Stacked

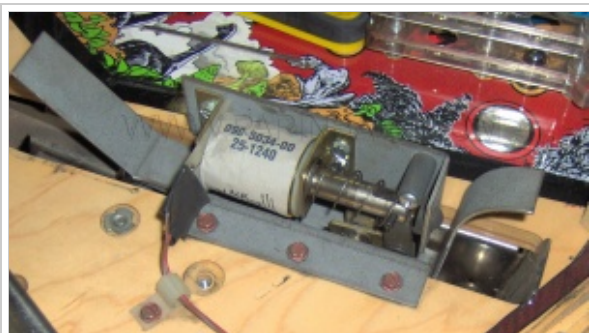
Lock Ball Assembly (from Jurassic Park - used for illustrative purposes)

Please note that a "Lock Ball Assembly" was employed in the trough design on early White Star games. The lock ball assembly is a unit, which was carried over from later Data East and early Sega games. It consists of a coil mounted horizontally above the left side of the trough VUK. This assembly was later removed presumably either due to cost factors, or so this coil assignment could be used as a playfield coil feature elsewhere instead.

If a lock ball assembly is used in the game, and trough opto failure has occurred, the symptom will more than likely be that the trough VUK will fire repeatedly without a ball present above the VUK

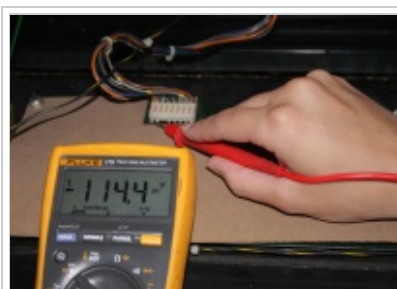
Testing DMD Controller voltages at the display. Note: This picture is a Williams game, but the concept is the same.

Note that a failing or failed DMD display glass can drag these voltages down. Before you begin any work on the HV Power Supply board, perform the above test with the DMD display power disconnected. If the voltages return to nominal values, it's possible that your display is the culprit. Test the high voltages with a known good display to isolate the fault to either the HV Power Supply or the display panel.

To test for the voltages necessary for the DMD to operate, first open the backbox, and rest the DMD panel face down on the glass. Or, if the game has a "Showcase" style head (i.e. StarShip Troopers), swing the panel open to gain access to the HV connection to the DMD. The simplest place to test the voltages is at the display end of the power wire bundle as shown in the picture. **SAFETY WARNING: Your left hand should be in your pocket, to avoid a potentially serious shock. We are working with high voltages, so be VERY CAREFUL. Keeping one hand in your pocket is a good practice to follow as it eliminates the easy electric current pathway across your heart. A DMD controller provides enough electric current to kill you!**

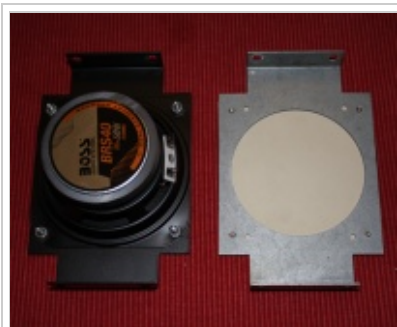
Adding a second backbox speaker may improve the sound in games shipped with a single backbox speaker. Buy the speakers in pairs. This image shows the new speaker installed onto the left speaker bracket, and the right speaker position "blank" from a StarShip Troopers game. The "blank" must be modified so that the new speaker can be attached.

Mounting the additional speaker to the "blank plate" (as found in StarShip Troopers) required drilling the rivets that attach the speaker grill, and replacing them with low profile head screws. This is only necessary for Sega "Showcase" backbox games. For games like Independence Day, mounting the additional speaker should be trivial.
